Manhole Inspection Summary

Manhole # S15MM1015MH

Insp Date: **12/5/06 10:54 AM**

Location Address: **4571 THE STRAND**

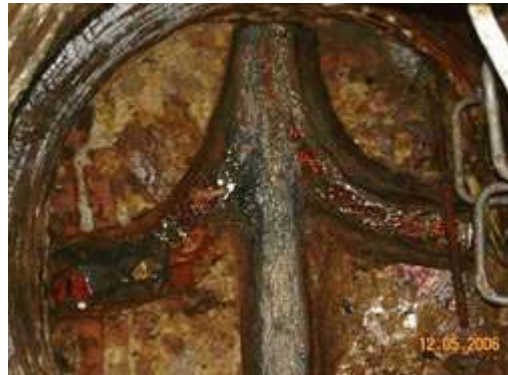
Top View

Barrel infiltration. Evidence of surcharge - Bench debris. Channel debris.

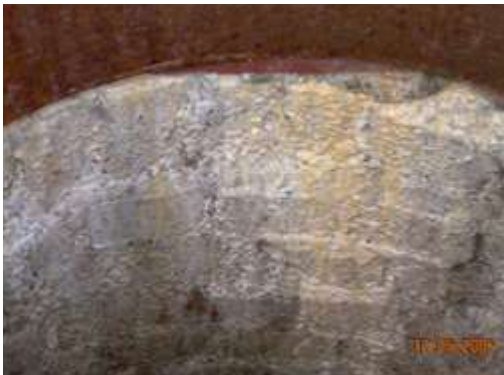
Defect

Adjustment infiltration - Mineral deposits.

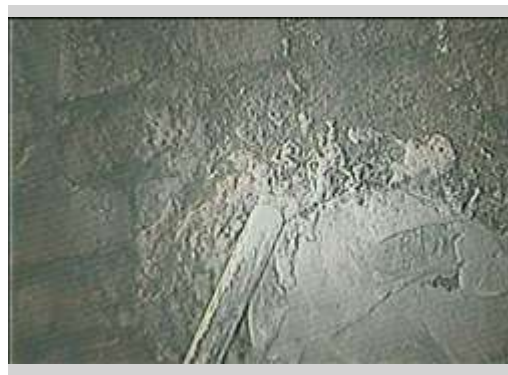
Defect

Barrel patch.

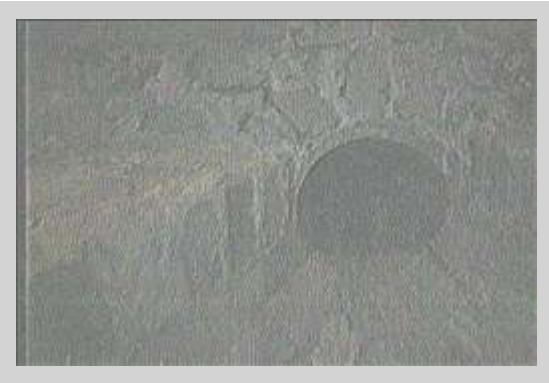
8 in. Circular Gravity Sewer Pipe Out @ 12 O'Clock

Infiltration: **Evidence** Pipe Seal Cond: **Unknown**

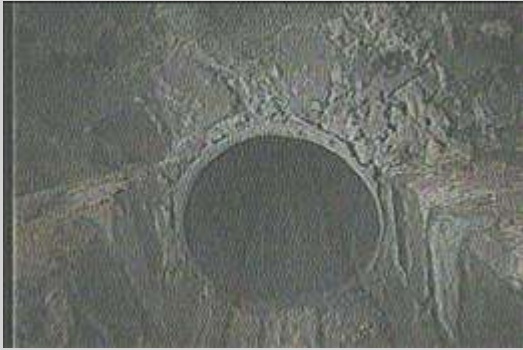
Pipe In @ 6 O'Clock

Infiltration: **Evidence** Pipe Seal Cond: **Cracked**
